Docket No. 217 – Development and Management Plan Inspection

Date: July 28, 2004

Location: Norwalk Substation Expansion

Location: Plumtree Substation Expansion , Bethel

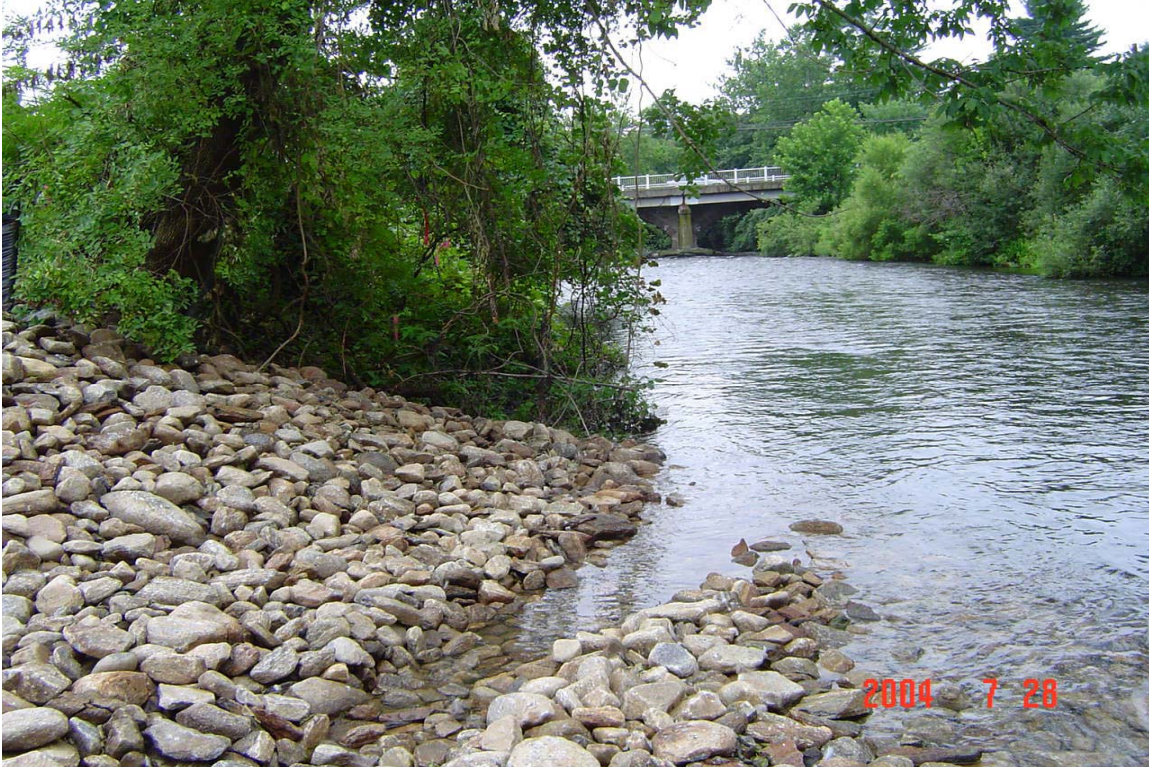
View of the connection to the Norwalk river at the southern end of the overflow channel. The water level was fairly high at the time of inspection due to recent heavy rains. 7/28/04

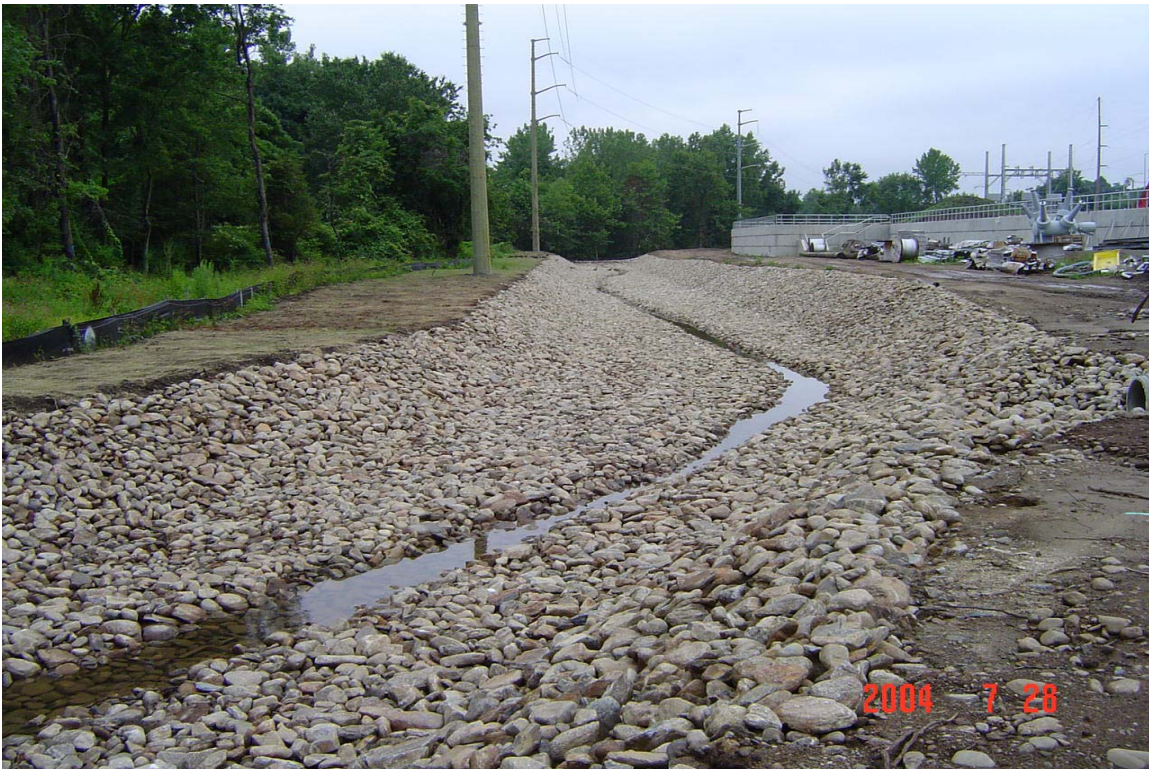
The overflow channel has been completed and the meandering channel held standing water during the inspection following the rains. 7/28/04

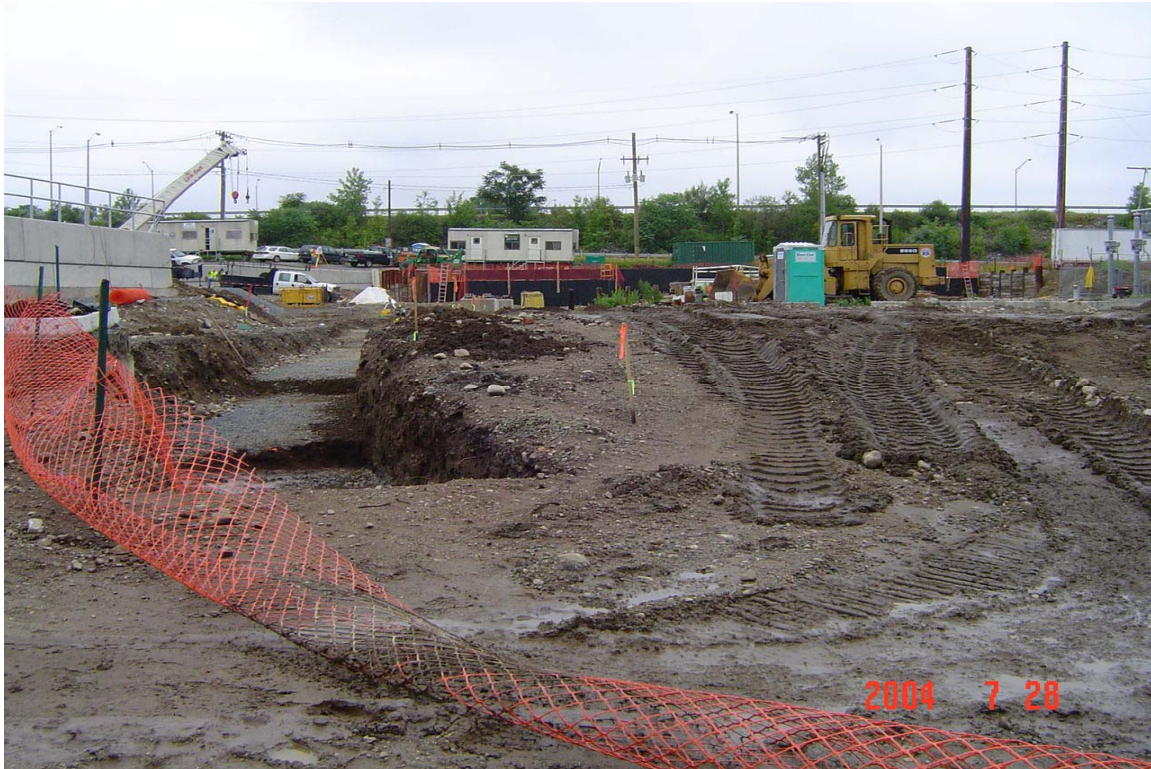
View of excavations for foundations and footings for structures including future placement of wall #3. 7/28/04

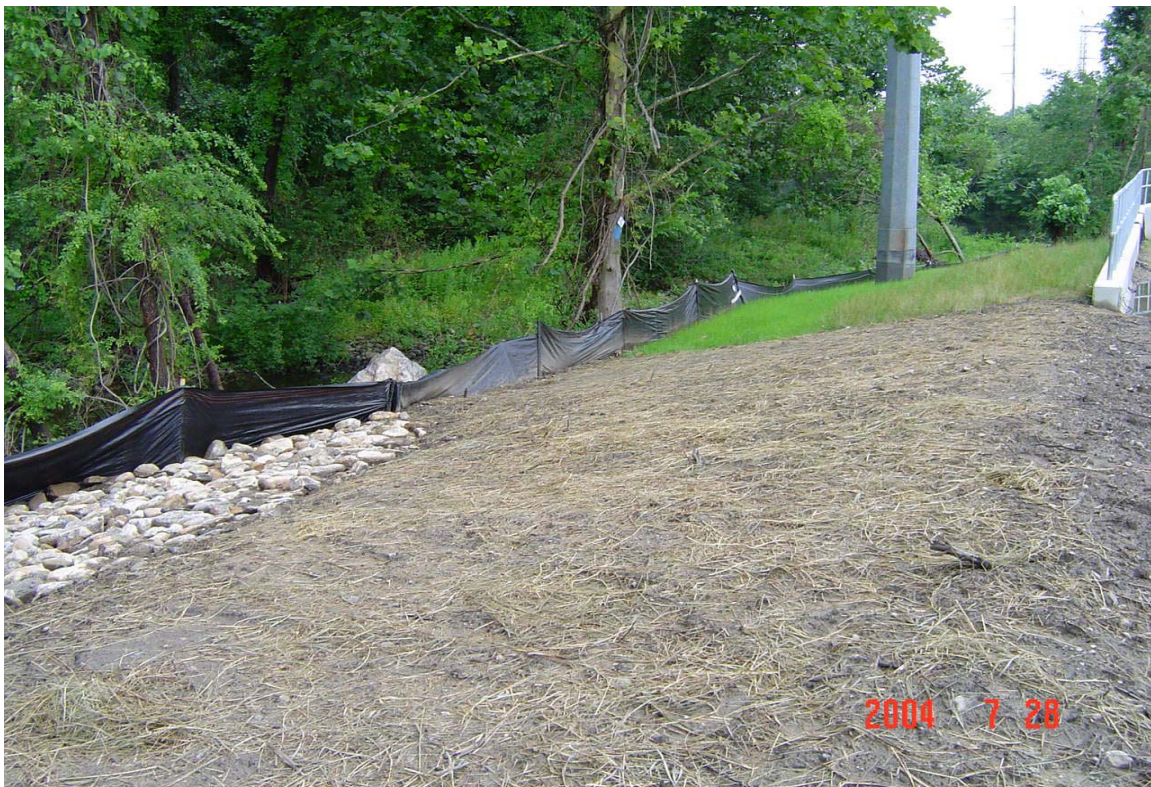
View of the area where the sheet piling had been removed. Although the area has flooded, all work was able to be completed in dry conditions. The area has been seeded and mulched 7/28/04

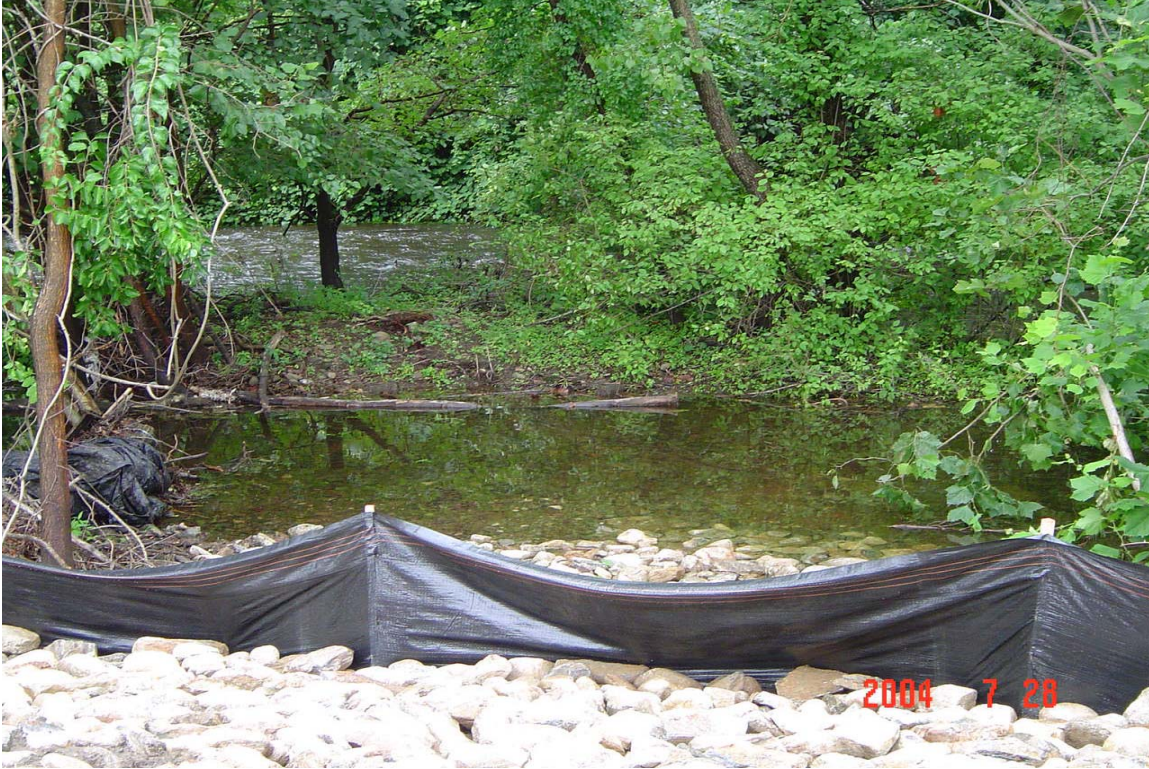
View of the northern end of the overflow channel connecting to the Norwalk river. The area has flooded following the rains but the channel was working well. 7/28/04

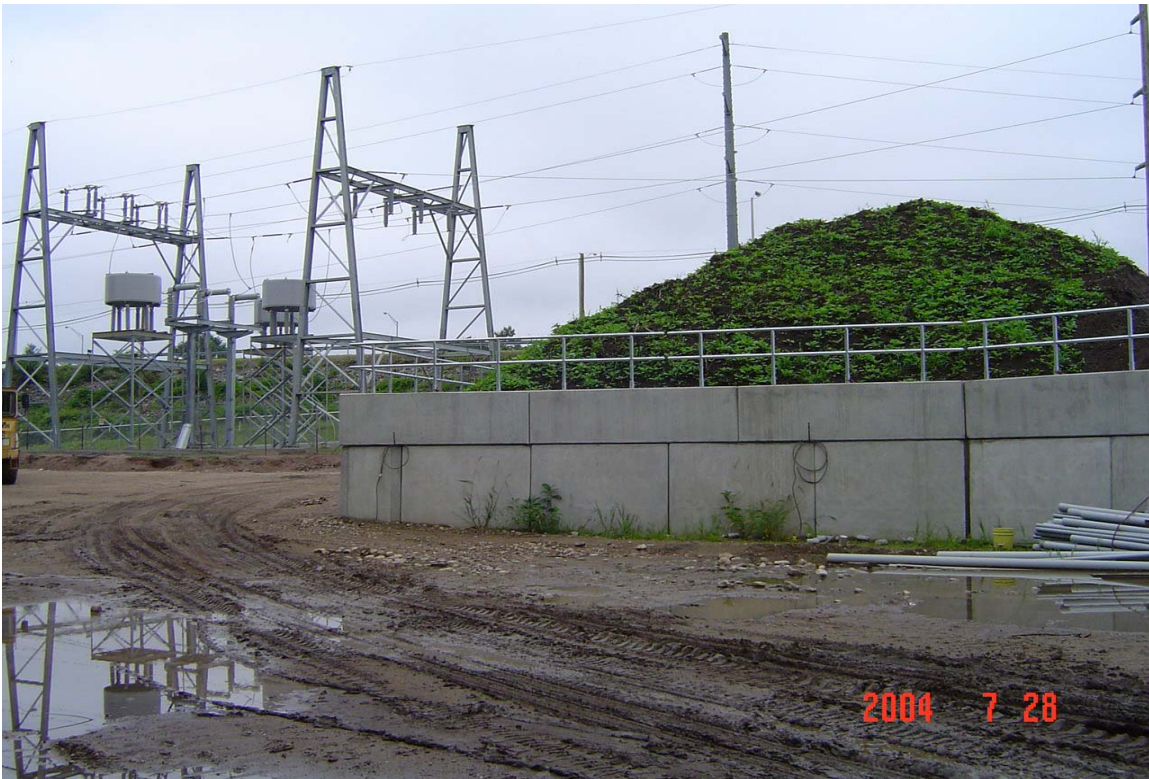
View of the topsoil stockpile well contained within the retaining wall. 7/28/04

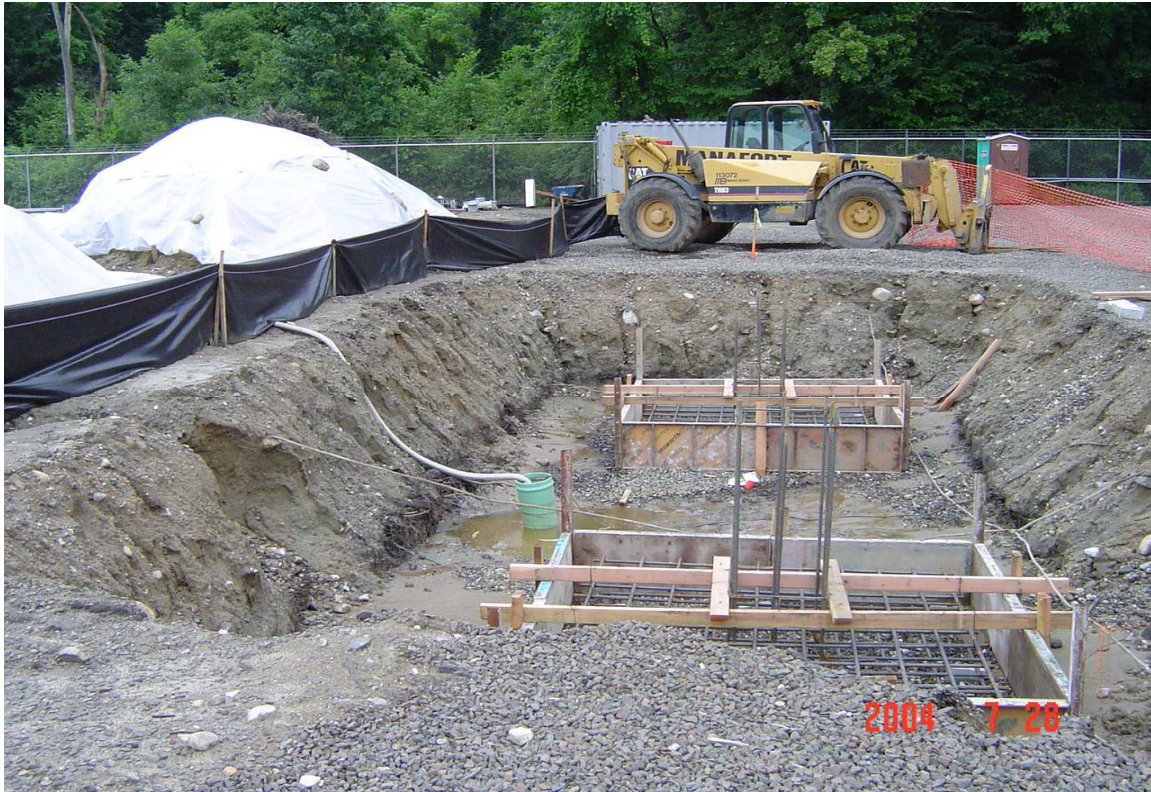
View of one of the excavations at Plumtree. The rains caused erosion and washouts back into the trench but did not affect other portions of the site. 7/28/04

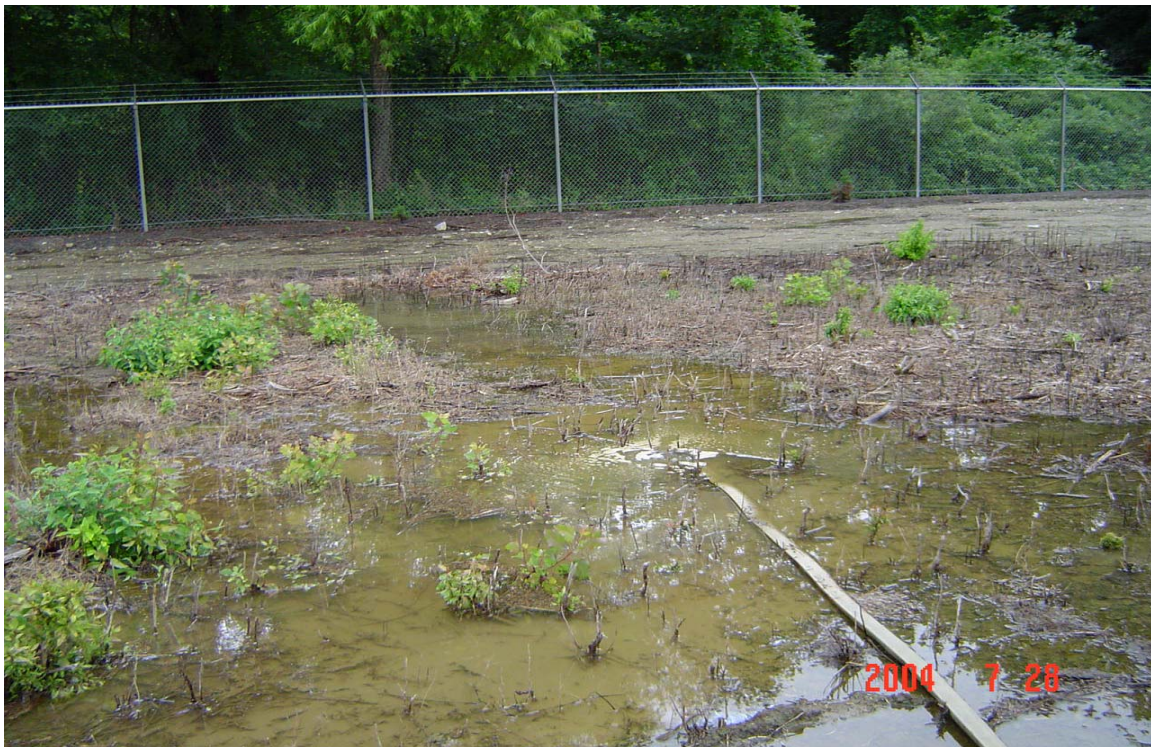
The excavations are being dewatered as a result of the rains and groundwater level. The water is being directed to the yard and has not reached any adjacent wetland areas. The hose will be pulled back to provide even more clearance room to the resources. 7/28/04
